# KENTUCKY TRANSPORTATION CENTER

**MAINTENANCE PAINTINGS OF  
VARIOUS BRIDGE PROJECTS  
DURING 2001-2002  
Kentucky Highway Investigative Task #42**

**Research Report  
KTC-03-04/KH42-01-1F**

**Maintenance Painting of Various  
Bridge Projects During 2001-2002**

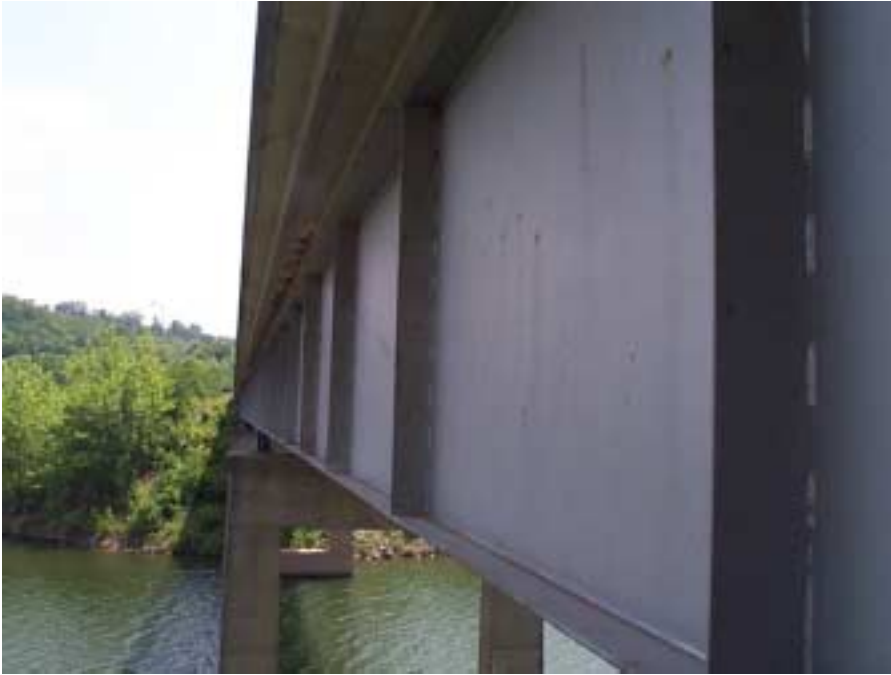
The existing coating included a 615D red-lead primer with one coat of 615D with lamp black intermediate and one coat of nonleafing aluminum top coat. The existing coating was very brittle and dirty with very little rust (3).

Figure 24. The condition of the bridge prior to the onset of work.

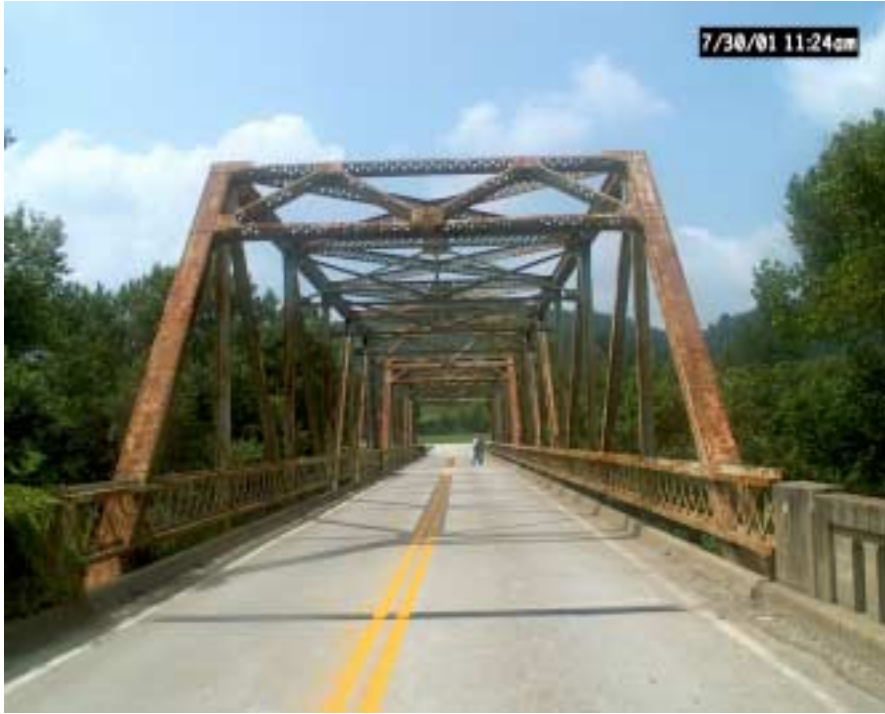
Figure 29. The condition of the bridge prior to painting.

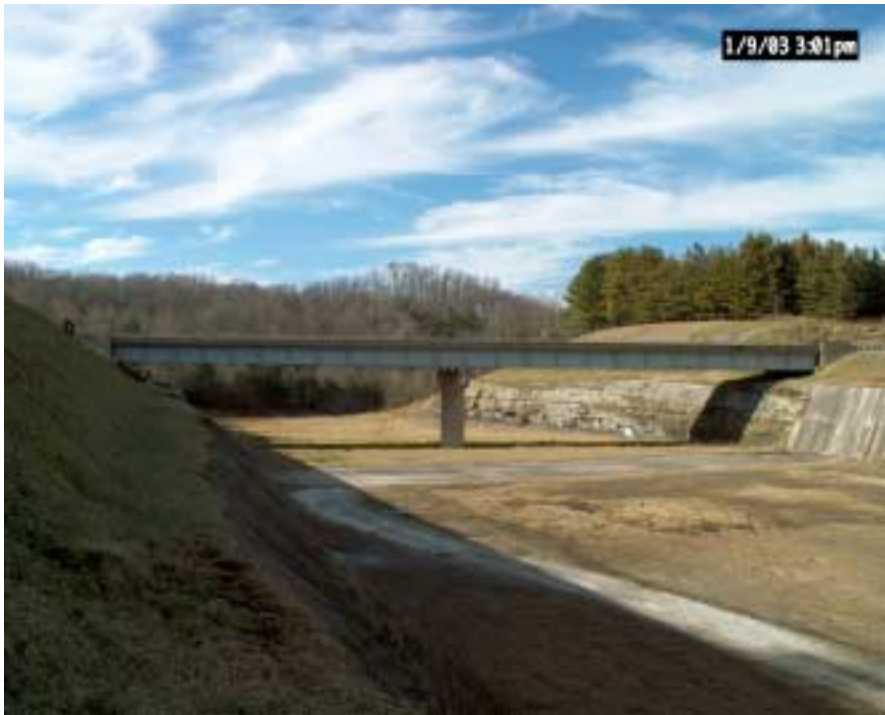
Figure 34. The bridge at KY 7 over the spillway before painting began.

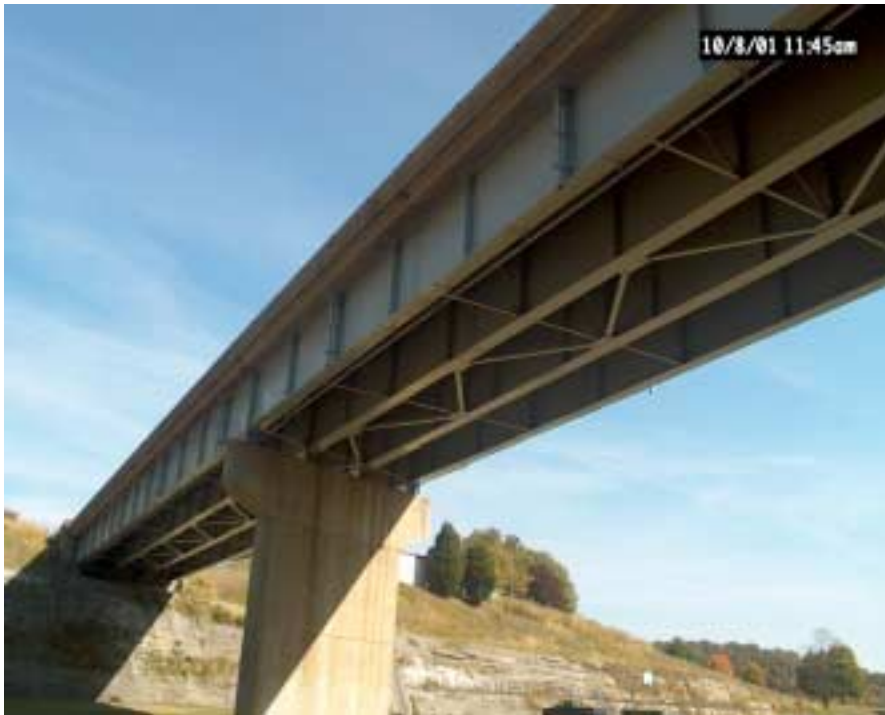
Comments from final inspection report were as follows: "The finish coat had areas of lifts and areas of separation where the continuity of the coating film had been broken. These areas will require additional application of topcoat to achieve a continuous film. Repair holidays and missed spots with finish coat. Touch up where rigging has been removed. Stenciling of the appropriate information is also needed. The work area must be cleaned and all debris and waste removed from site."

Figure 38. The KY 7 Bridge over the spillway after painting.

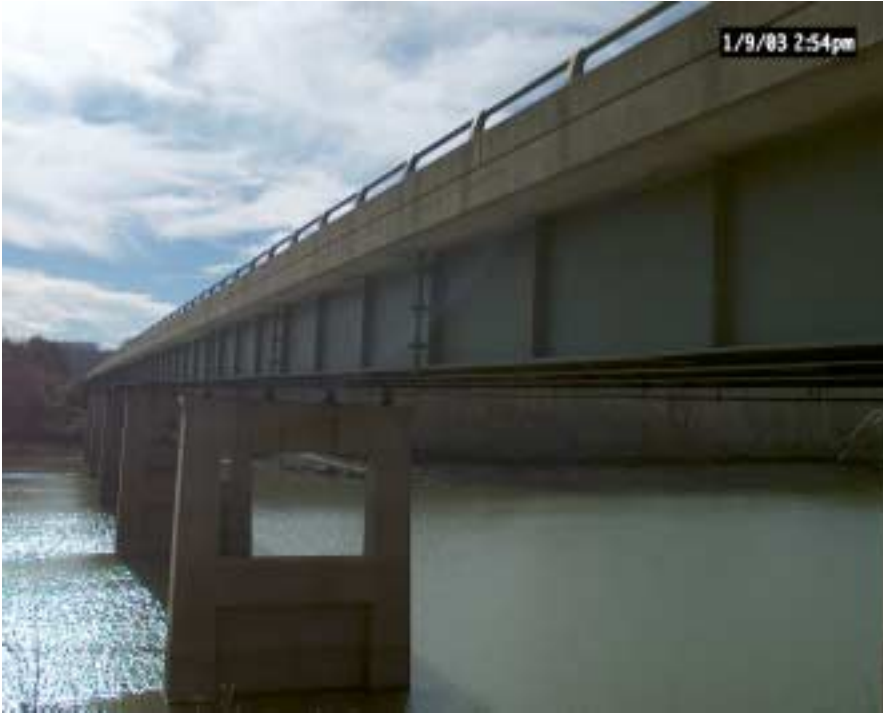
Figure 39. The KY 7 Bridge on Grayson Lake prior to painting.

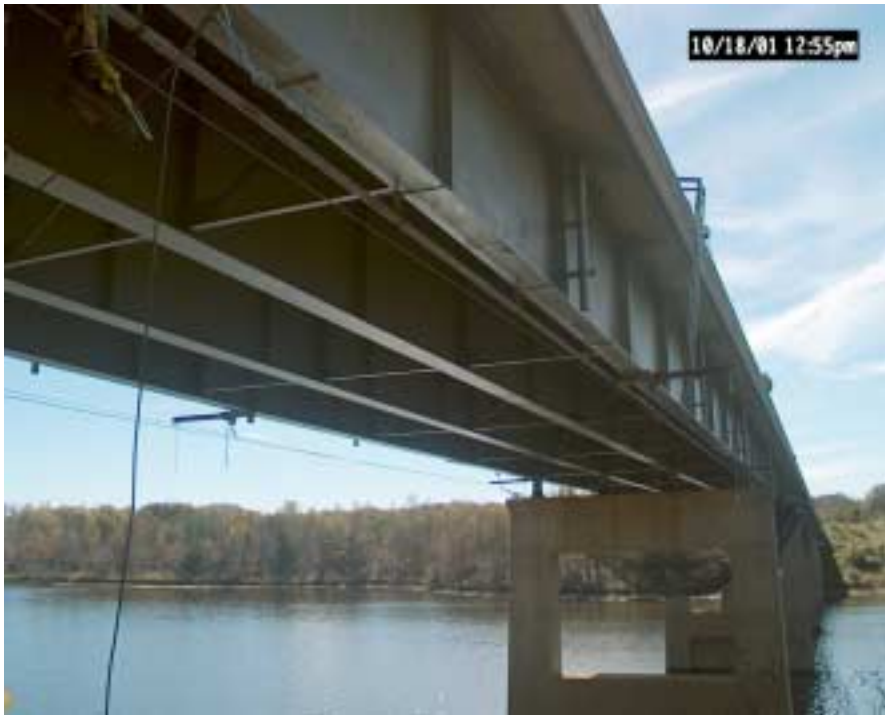
Comments from the final inspection report were as follows: "Repair holidays and missed spots with finish coat. Touch up where rigging has been removed. Stenciling of the appropriate information is also needed. The work area must be cleaned and all debris and waste removed from site.

Figure 41. The completed experimental coating during the final inspection of the bridge.

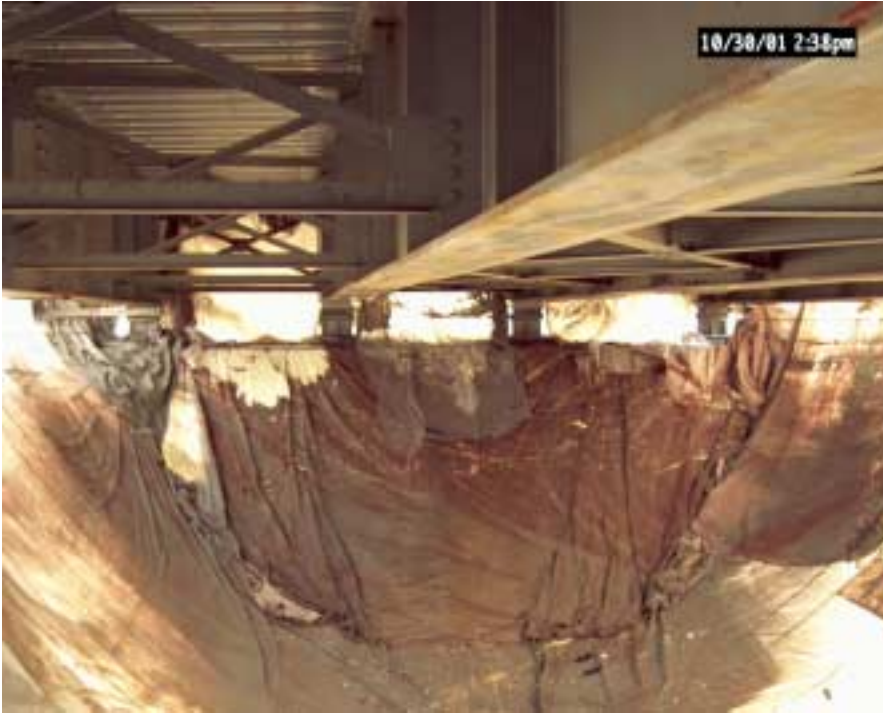
Figure 70. View of holes and openings in the containment on the KY Bridge 9002 in Nelson County.

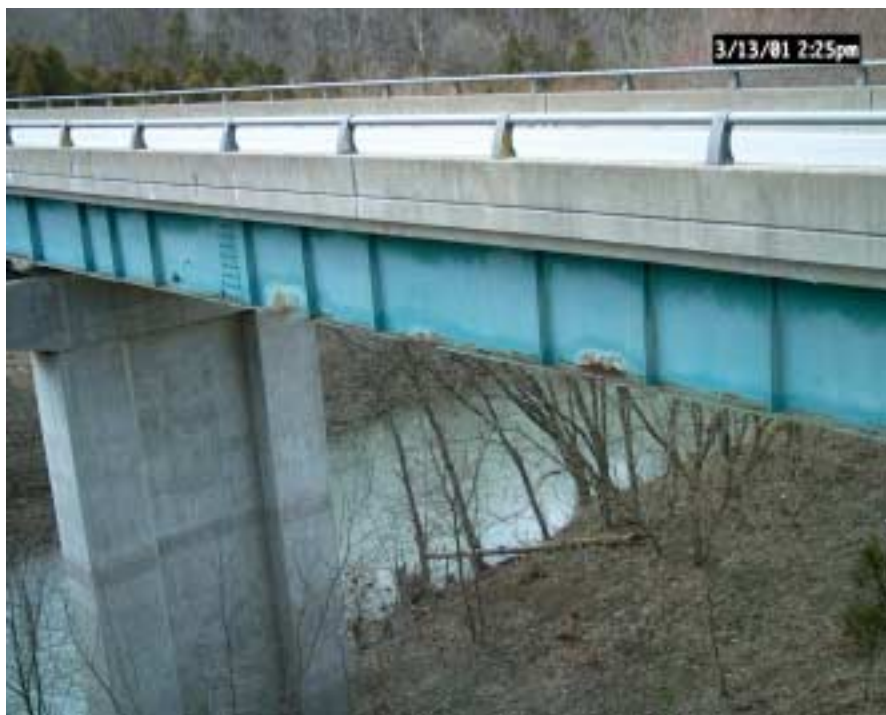
Figure 80. General condition of the bridges on KY 9002 in Washington County before painting.
